# The Friends of the Pine Creek Grist Mill

## Restoration Progress Report 100!

September 8, 2018

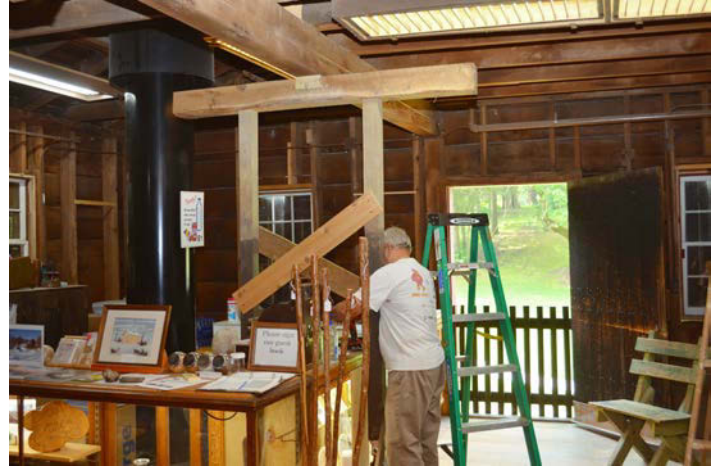
**Hank Mann is screwing the last cross brace to the posts that are being used to lift the sagging beam above.**

This month we started working on the sagging beam that is located above the counter in the country store area. Because the beam is exactly above the center line of the counter we had to be inventive about how we raised the beam. The method we used is to have a beam at a right angle under the sagging beam. It would be lifted by two posts, one on either side of the counter. The posts in turn would be lifted by two bottle jacks.

To make sure that none of this could possibly fall all of the parts were bolted and screwed together. A taught string is used to indicate how far we lift the sagging beam every week. We decided not to lift the beam over 1/4" a week to prevent the wood from cracking. As of our last work day we have raised it 3/4"

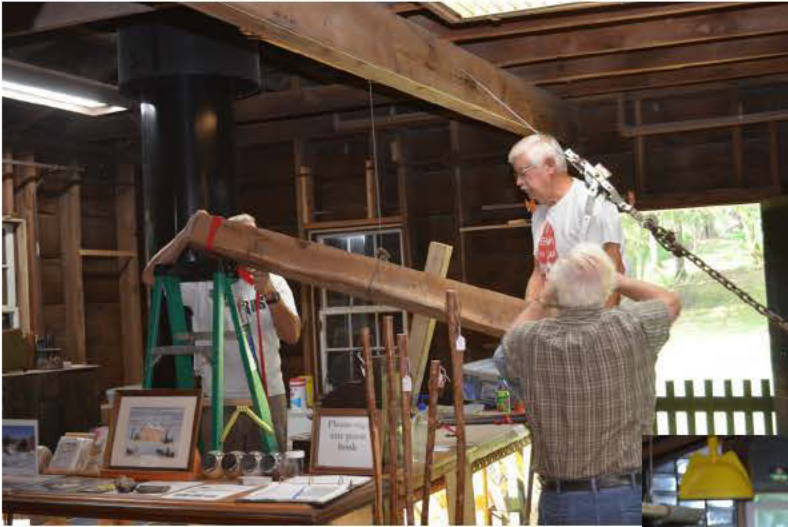
At left Hank Mann, Dick Stoltenburg and Clarence Klauer are hoisting the cross beam into place using a come-a-long.

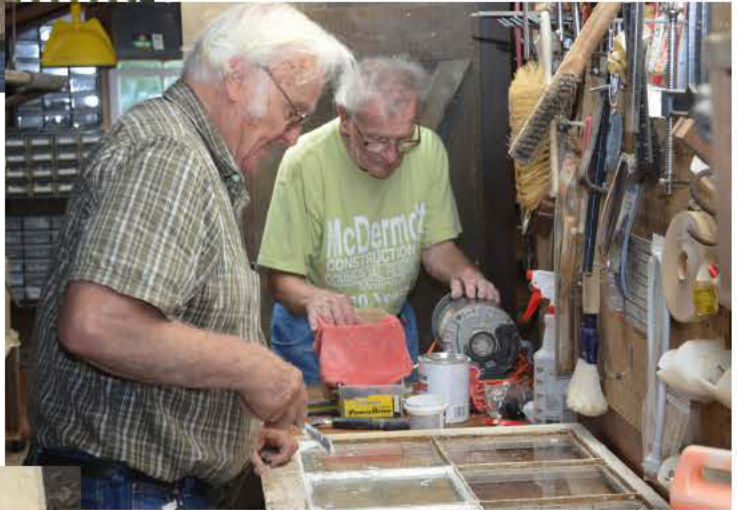
At right the Klauer brothers are replacing the glazing putty on one of the windows that we are restoring.

We are still working on restoring the same two windows that we started on last month. Since you have to wait until our next work day for the putty or paint to dry, this project is taking a long time.

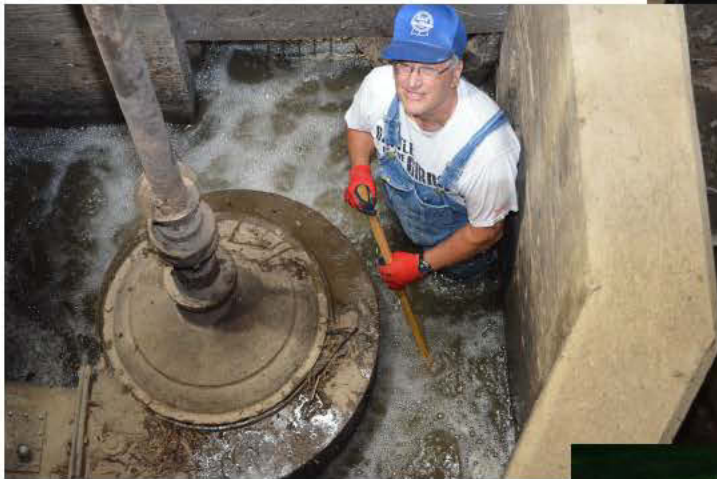
That's Hank Mann in his element cleaning the mud from the turbine pit.

Hank Mann cleaned out the yearly build up of mud from the turbine pit this month. A nasty job if there ever was one. We are very lucky to have someone who wanted to tackle this job.

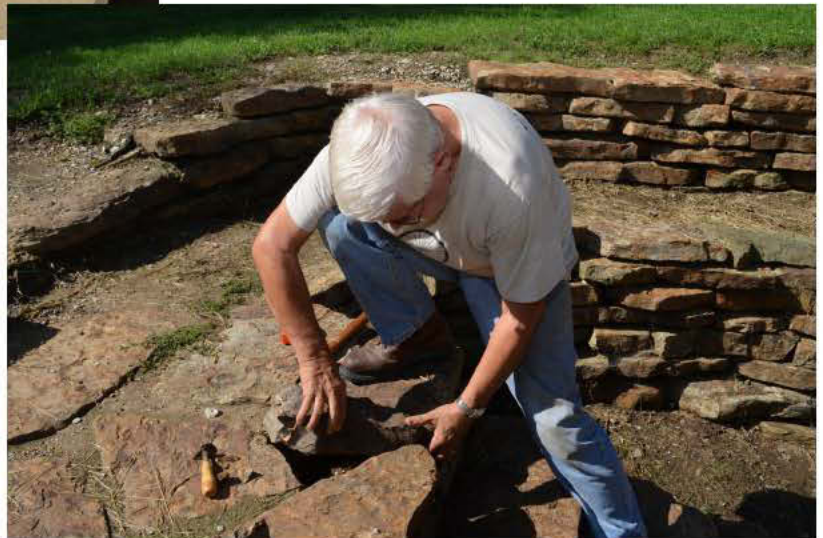
Dick Stoltenburg is our stone mason. Here he is doing the final fitting of a replacement stone on the boiler room steps.

Dick Stoltenburg noticed a serious safety hazard that had developed in the stone steps that lead down to the south boiler room door. At near the top of the steps a missing rock had formed a near perfect wedge shaped foot trap. Anyone that got their foot caught in it ran a risk of breaking an ankle.

Down by the creek Dick found a scrap of the same kind of stone that the steps were made from. After cutting it to

shape and it fit into the hole eliminating the hazard.
