# The Friends of the Pine Creek Grist Mill

## Restoration Progress Report 87 August 13, 2016

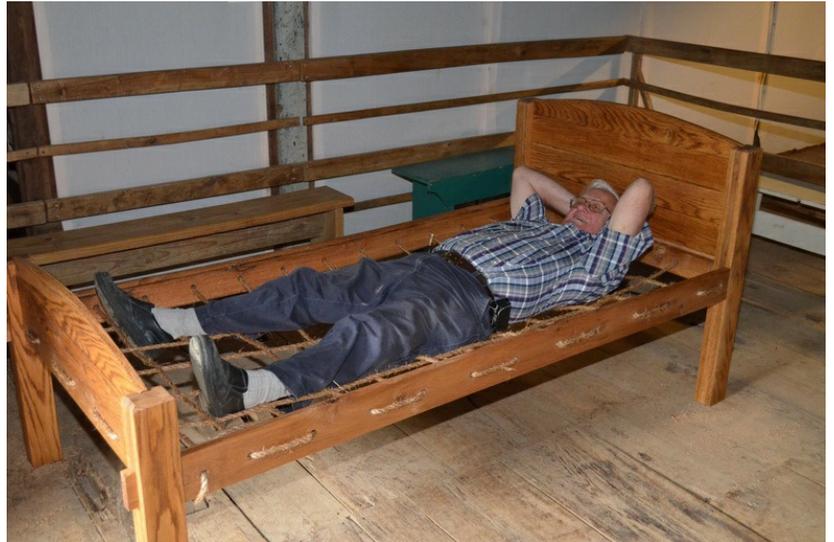
**Clarence Klauer is giving our new pioneer rope bed the final test**

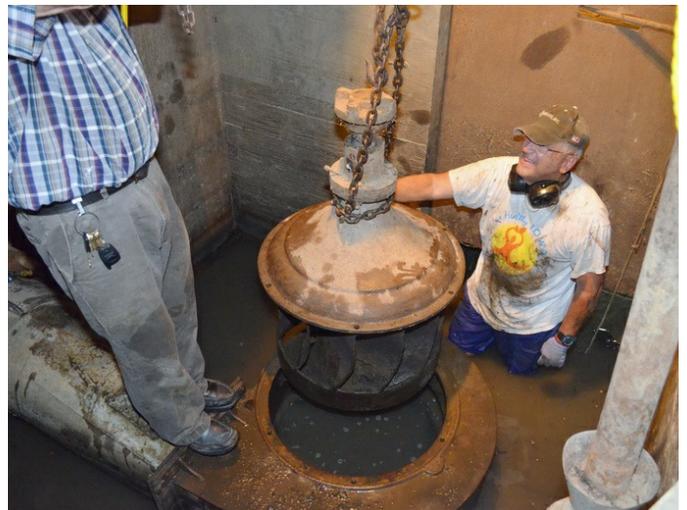
**Above Hank Mann is using a pipe wrench to attempt to free up the turbine runner. The gate is open allowing water to boil out from under the turbine.**

It took little work to disengage the bevel gears so the turbine shaft could turn when the penstock gate is open. The problem is that the turbine would not turn at all when the water came on. To get it turning again would require the runner to be lifted out of the turbine case, the problem found, corrected and the turbine reassembled again. To my remembrance the turbine had not been disassembled since the late 1990's, the time had come for it to be serviced again.

Tom Hanifan often says he is amazed by how we always seem to have just the right people to help us when we need them. In this case Hank Mann had experience working on hydroelectric turbines, giant machines compared to our little turbine. Being a professional diver, he had no calms about jumping into the turbine pit to work on the machine. First we rigged our chain hoists to remove the turbine shaft and gear. Then a second hoist was rigged to lift the runner out of the turbine case.

What we found is that rust scale had built up on the edge of the runner that rubbed against the turbine's casing. The lubrication had failed in the turbine's top bearing causing drag. Once the old grease and dirt had been cleaned out and the rust removed (with an air powered rust chipper) the turbine started to spin freely again.
