# The Friends of the Pine Creek Grist Mill

## Restoration Progress Report 89

Sept. 10, 2016

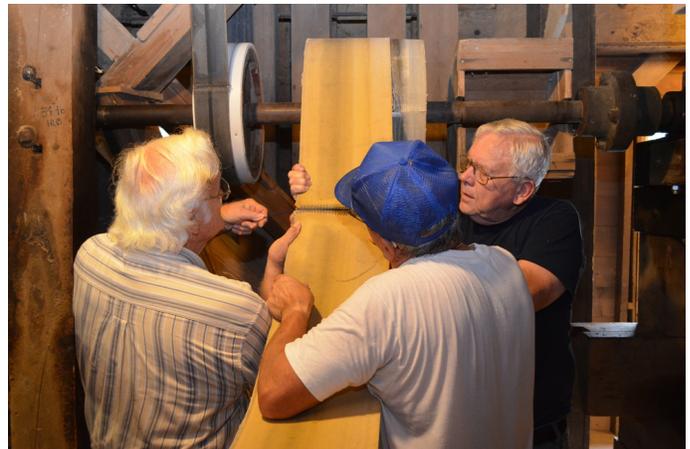
Now comes the hard part! Once the new splice is installed the link pin has to be installed in the belt and the belt slid back onto its pulleys.

Another issue we dealt with is a torn splice on the flat belt that connects the main line shaft in the basement with the millstone drive jackshaft. This belt has a 90 degree rotation in it and because it has to make this turn there is a considerable amount of tension on it. About once a year the belt splice tears out and has to be replaced.

This time I used the repair / replacement of the belt splice lacing as a training exercise, the newest members of the restoration crew had never seen a wire lacing splice installed in a flat belt. Now they know how to use the lacing machine and properly install a new splice.
